Using an IR-InSight™ to do an infrared roof inspection

Introduction

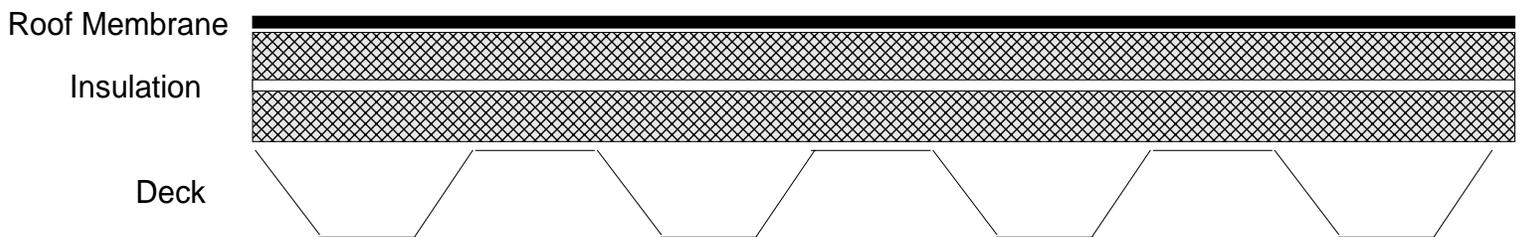
Figure 1: Cross section of a typical Flat Roof

The roof deck supports the roof and the roof load. The types of roof deck whether it is steel, wood, tectum (wood fiber in cement mixture) or concrete has no bearing on the infrared inspection.

Insulation is installed on top of the structural decking. Roof insulation is manufactured in boards of varying thickness and can be categorized as either absorbent or nonabsorbent. Perlite, wood fiber, cork and fiberglass are examples of absorbent insulation. Extruded polystyrene, foam glass, lightweight concrete, closed-cell polyisocyanurate, closed-cell polyethylene, urethane, and expanded polystyrene are examples of nonabsorbent insulation. It is important to note that different types of insulation will result in different thermal patterns. Identifying the type of insulation and the thermal pattern it will create is crucial before starting an infrared roof inspection.

The roof membrane is the waterproof barrier between the outside elements and the interior of the building. An effective roof membrane has to be waterproof, durable, able to expand/contract with the materials it is adhered to, resist forces of high winds, and support external loads. Hence, it is easy to see why roofs leak. Even though a variety of roof membrane materials are available, they can usually be classified as either built-up or single ply. Built-up roof membranes consist of layers of roofing felts that are adhered to each other with hot asphalt or coal tar pitch. Single ply membranes are large sheets of thick rubber or plastic material (e.g. neoprene, EPDM, PVC) that are usually glued down or held down with heavy stone ballast.

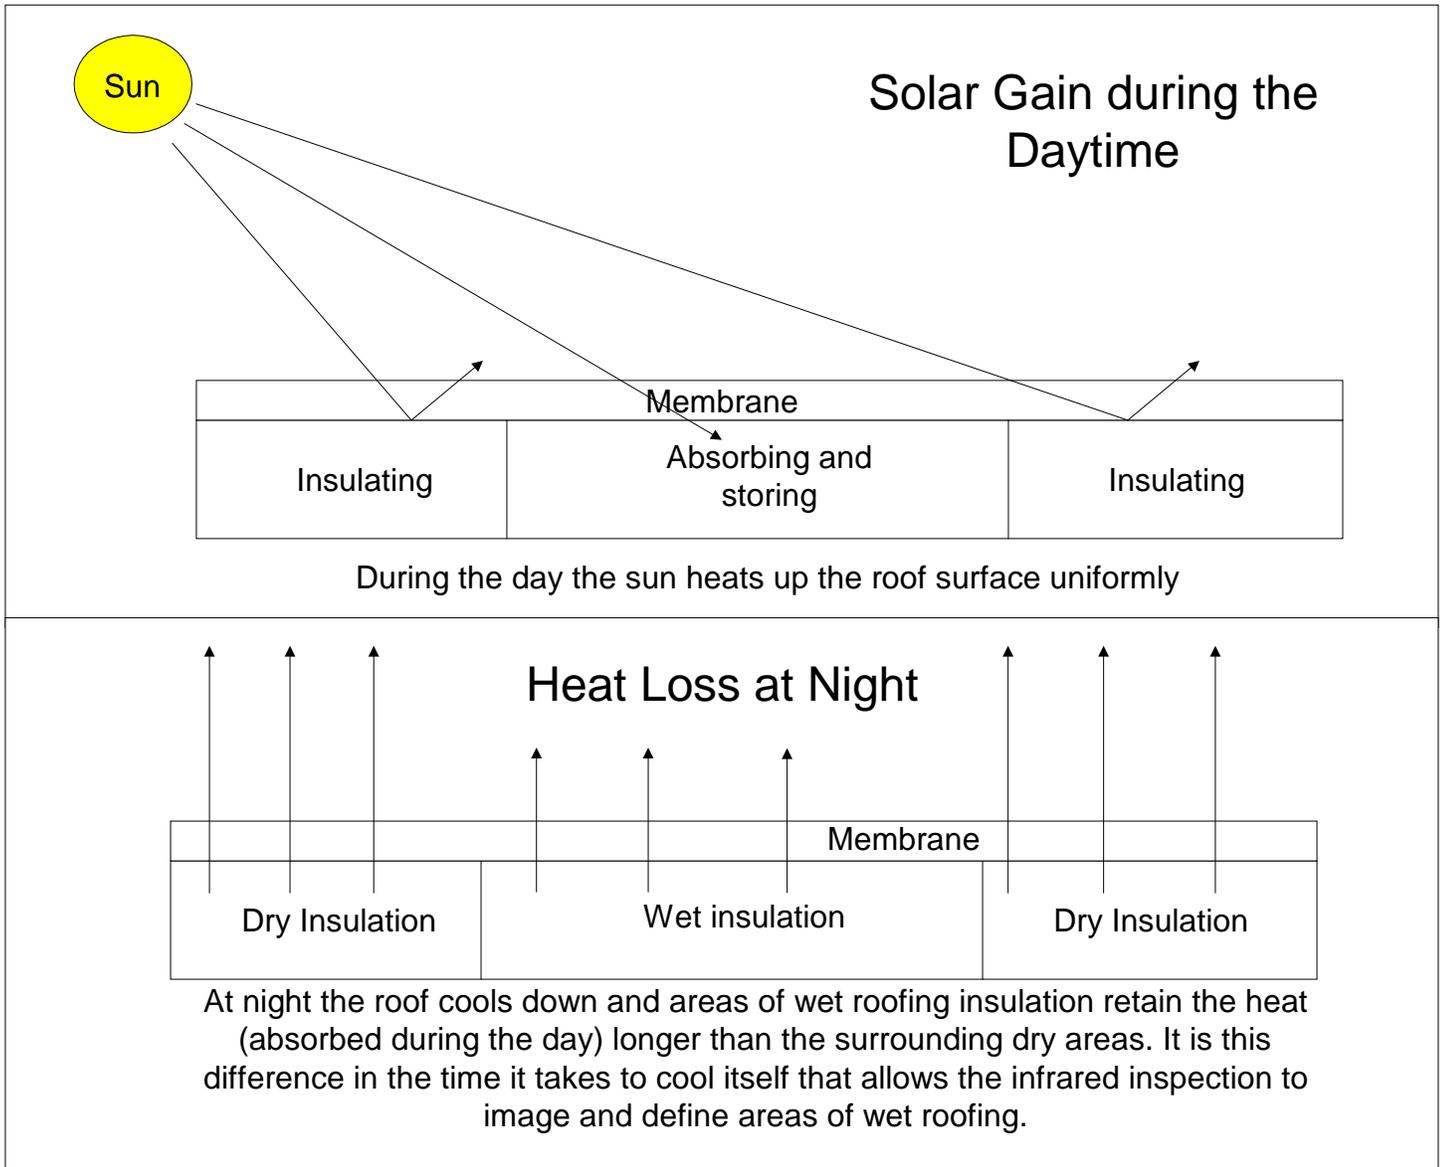
The physics used for thermal roof inspections is that dry roof insulation heats up and cools down faster than wet roof insulation. Infrared inspection goes beyond simply finding a leak by locating the extent of the moisture invasion of the insulation. However, it first requires solar heating of a sunny day. Then at dusk, after the sun goes down and the roof surface begins to cool, the dry roof insulation cools faster than wet roof insulation. This temperature difference can be detected by the IR-InSight™. Hence, the wet areas can be seen as warmer than the dry areas. By the same rationale, the

inspection could be carried out at dawn too because it takes longer for the water saturated part of the roof to heat up than the dry part and the wet areas could be seen as cooler than the dry parts. However, industry norm is for the inspections to be carried out around dusk.
